## PIC24F16KL402 Family Silicon Errata and Data Sheet Clarification

The PIC24F16KL402 family devices that you have received conform functionally to the current Device Data Sheet (DS30001037C), except for the anomalies described in this document.

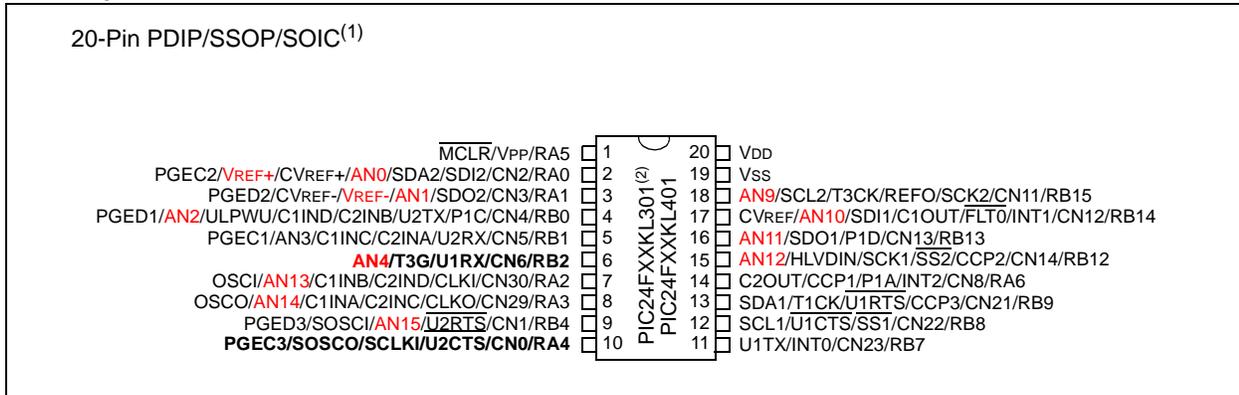
## Pin Diagrams: PIC24FXXKL301/401

The Pin Diagram: PIC24FXXKL301/401 20-Pin PDIP/SSOP/SOIC has the functions reversed for Pin 6 and Pin 10. The corrected pin functions are shown in **bold** below.
